DBC-16H Key Warranty Instructions

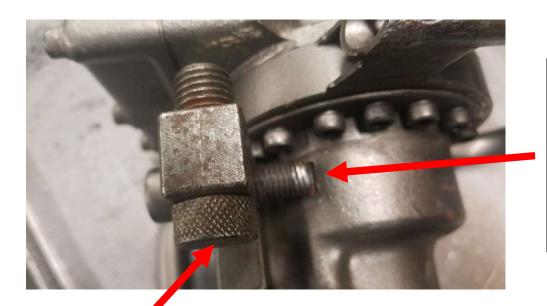
(was loose and off the housing when the tool was received. This prevents proper support of the stopper stay and will cause failure NOT covered under warranty)

(was firmly stuck in the stopper stay which is a clear indication that rebar has been bent improperly and not perpendicular to the bending rollers. This puts undue stress on the piston and the pinion and will cause tool failure NOT covered under warranty)

Cap bolt must be firmly tightened against the housing to help support the stopper stay.

Stopper bolt must be adjusted out to ensure the rebar is perpendicular (right angle) to the bending roller.
